Steve Steele's Home Inspections

Report: Smith,John **Address:** 832 Steele Road

Confidential Inspection Report
832 Steele Road
Murray, KY 42071

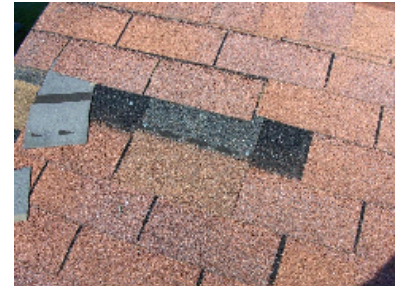
Roof Covering: Composition shingles. Damaged or missing Shingles noted. Repair/Replacement needed. **A licensed roofing contractor should be called to make further evaluation and repairs as needed.**

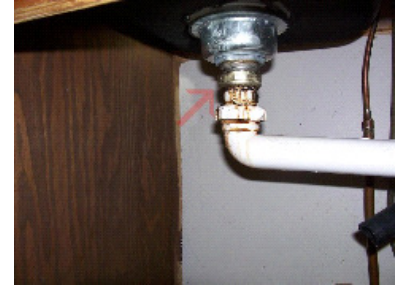
Kitchen Sink: Stainless Steel. Leakage is present. **A licensed plumber should be called to make further evaluation and repairs as needed.**

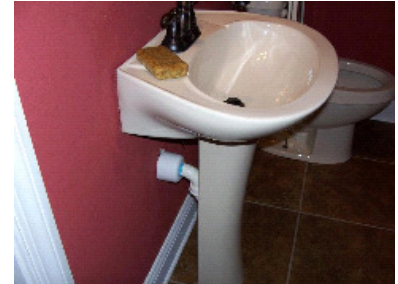
Master Bath:

The following problems were noted at the sink: The sink is loose. **A licensed plumber should be called to make further evaluation and repairs as needed.**
